COMMONWEALTH OF PENNSYLVANIA
Department of Transportation

RESEARCH PROJECT NO. 85-103

EVALUATION OF DURISOL SOUND WALL

FINAL REPORT
AUGUST 2000

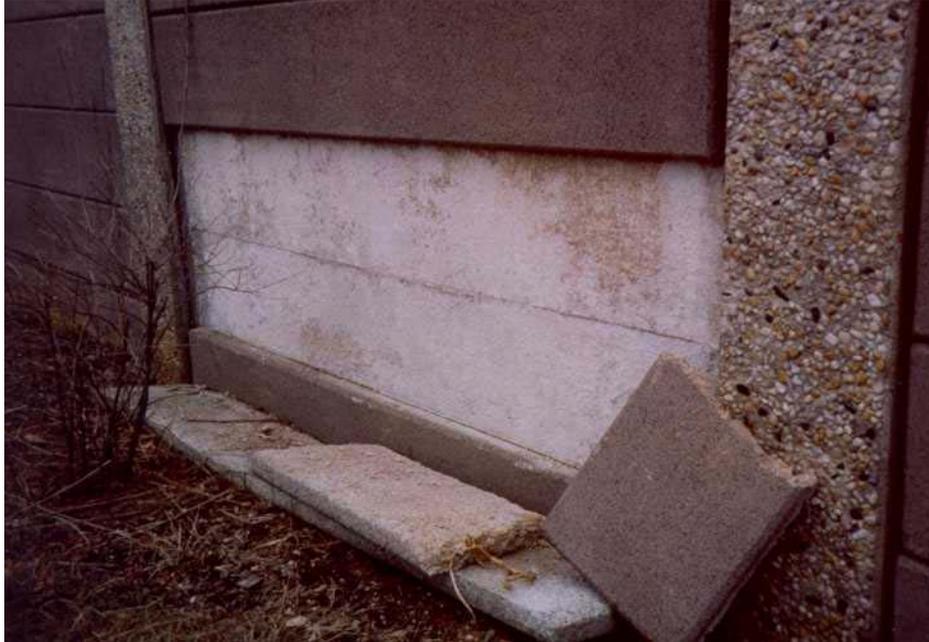
Observation of the Durisol noise barriers in the three counties indicates a tendency for the Durisol panel to debond from its concrete backing. Figure 1 is a photograph from the Lehigh County research site showing two panels completely detached from the concrete backing.

Figure 1-Panels detached from the concrete backing

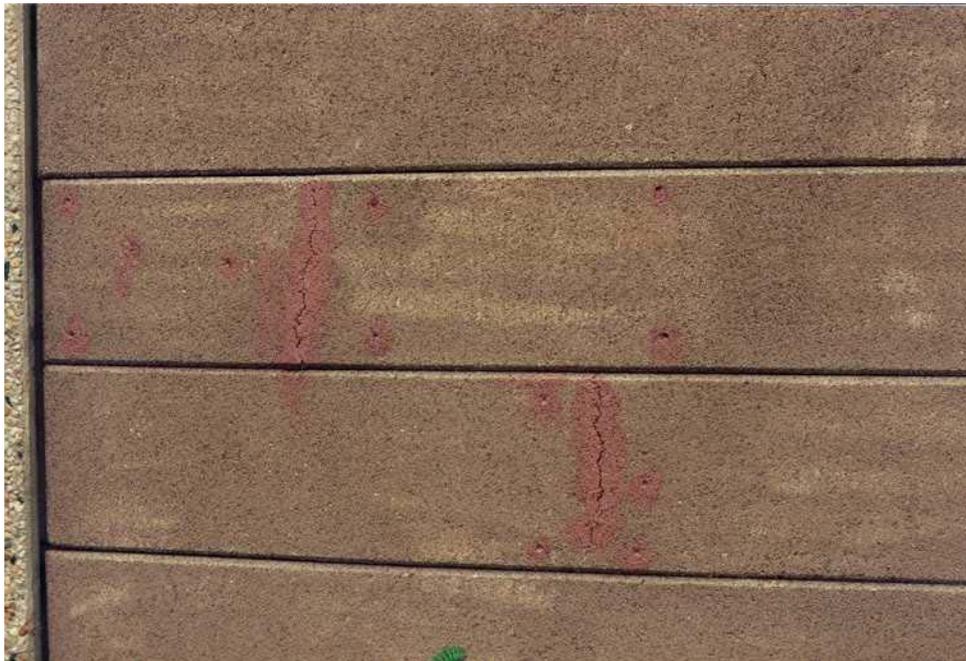
Debonding from the concrete backing can also result in cracking of the Durisol panel because it cannot support its own weight. Refer to Figure 2 for an example of cracks resulting from debonded panels.

Figure 2-Two cracks caused by panels debonding from the concrete backing

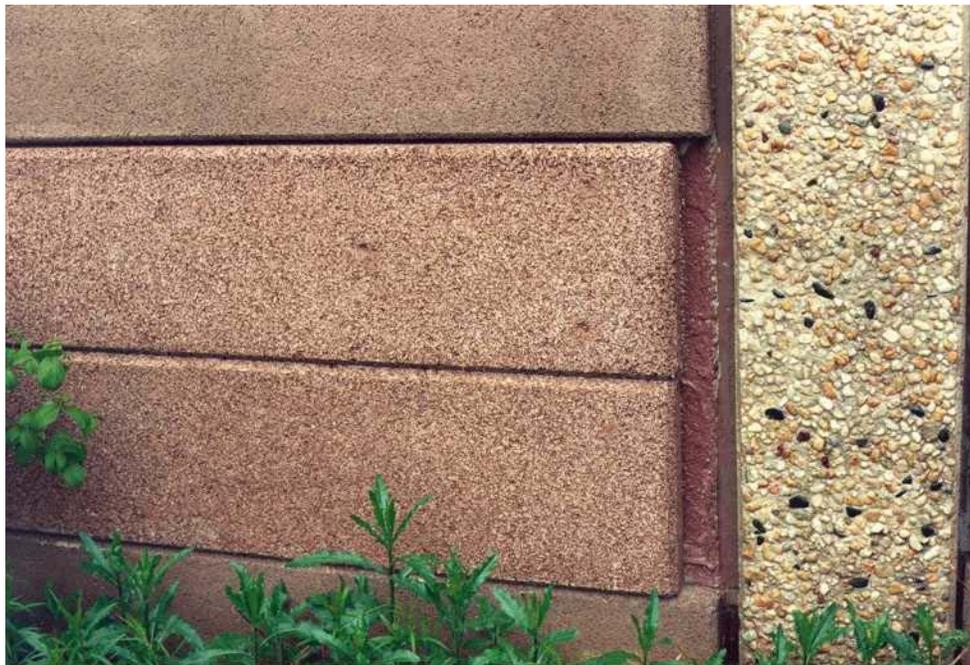
Repair of debonded panels reduces the aesthetics of the Durisol Sound Barrier. Figure 3 shows the repair of the detached panels shown in Figure 1. Often, debonded panels are reattached to the concrete backing via lag bolts. Both the lag bolt holes and cracks are sealed and painted, negatively affecting the aesthetics of the wall. Refer to Figures 2 and 4 to see repairs of debonded and cracked panels. These unsightly repairs can be seen throughout the Lehigh and Lancaster County research sites.

Figure 3- Repair of the detached panels shown in Figure 1

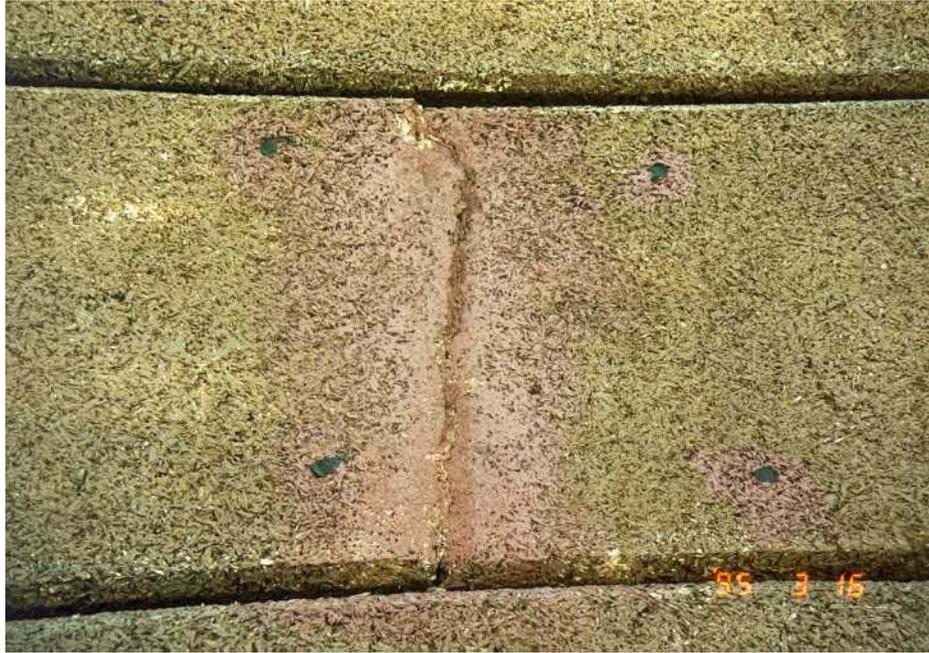
Figure 4-Repair of a debonded panel, which has cracked

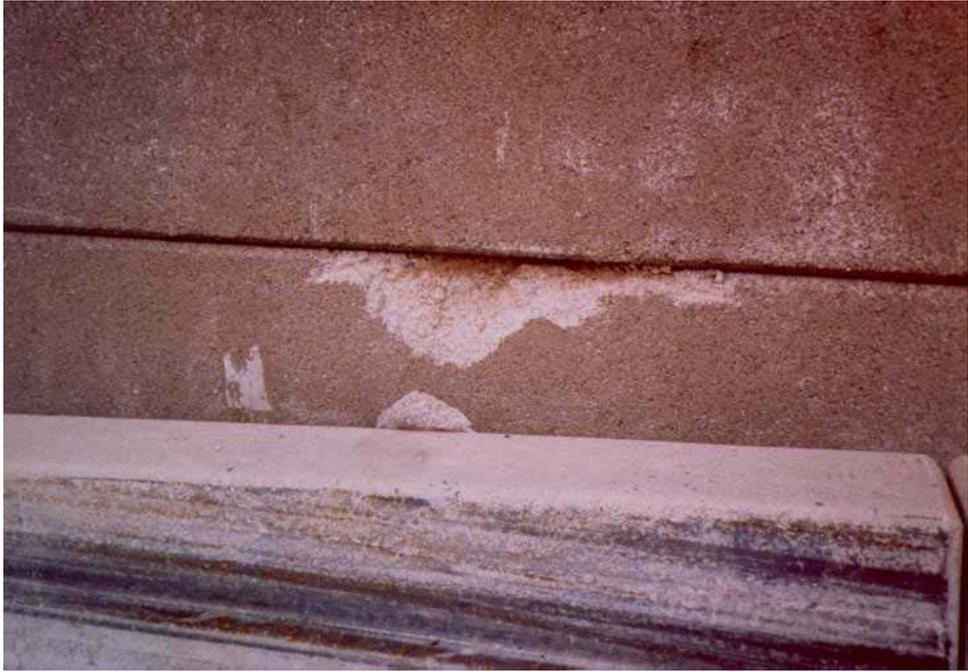
The Durisol panels in the noise barriers of all three research sites are susceptible to becoming friable and falling apart. Figures 5 and 6 show an actual spall, which has broken off the Durisol panel in the Lehigh County research site. Figure 7 shows a Durisol panel of the Delaware County research site breaking apart

Figure 5- A surface spall on the lower panel

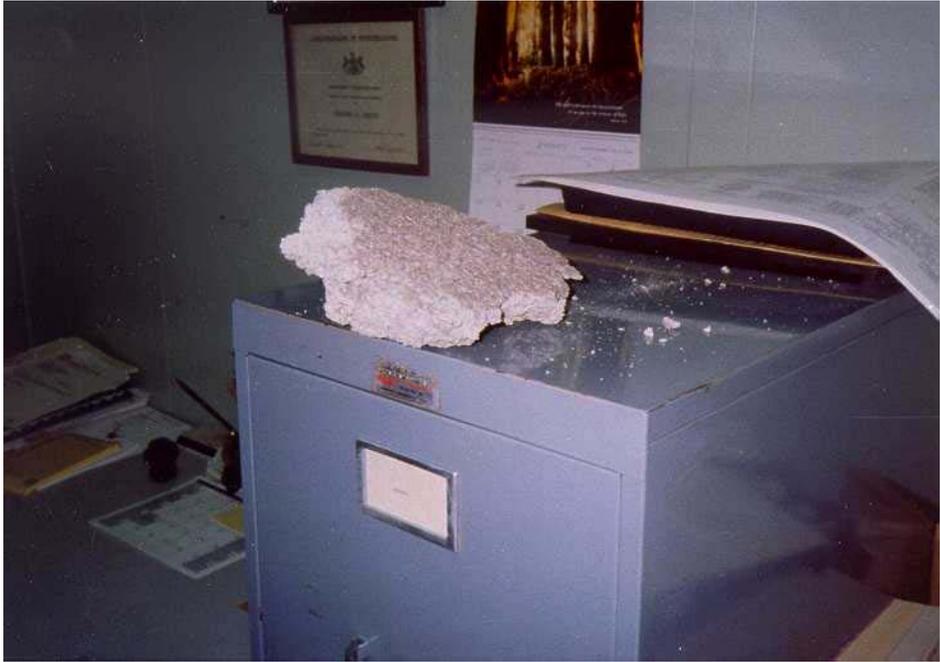
Figure 6- The actual spall from the above photo

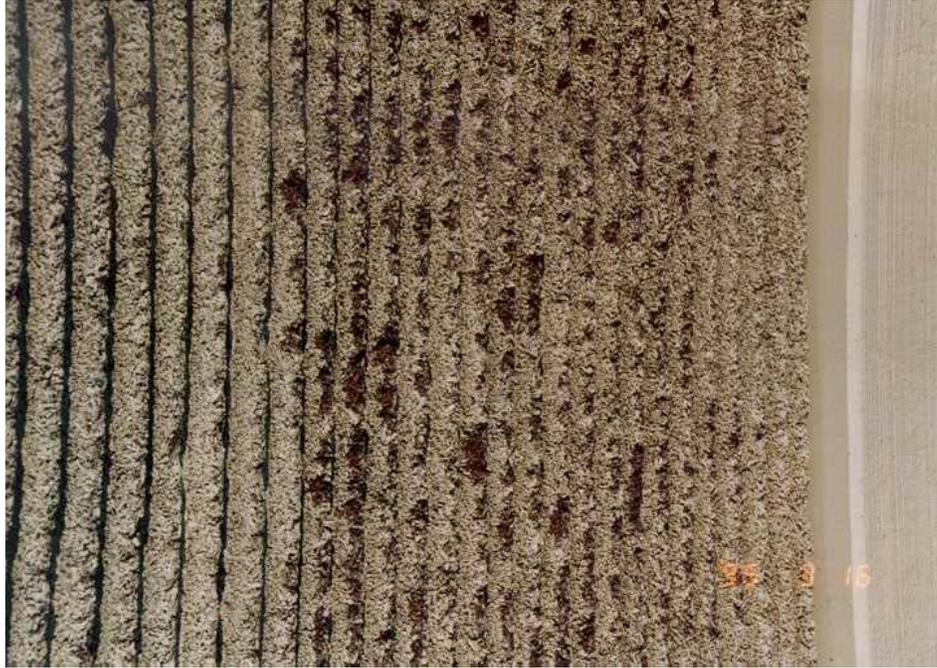
Figure 7-A panel from the Delaware County research site falling apart

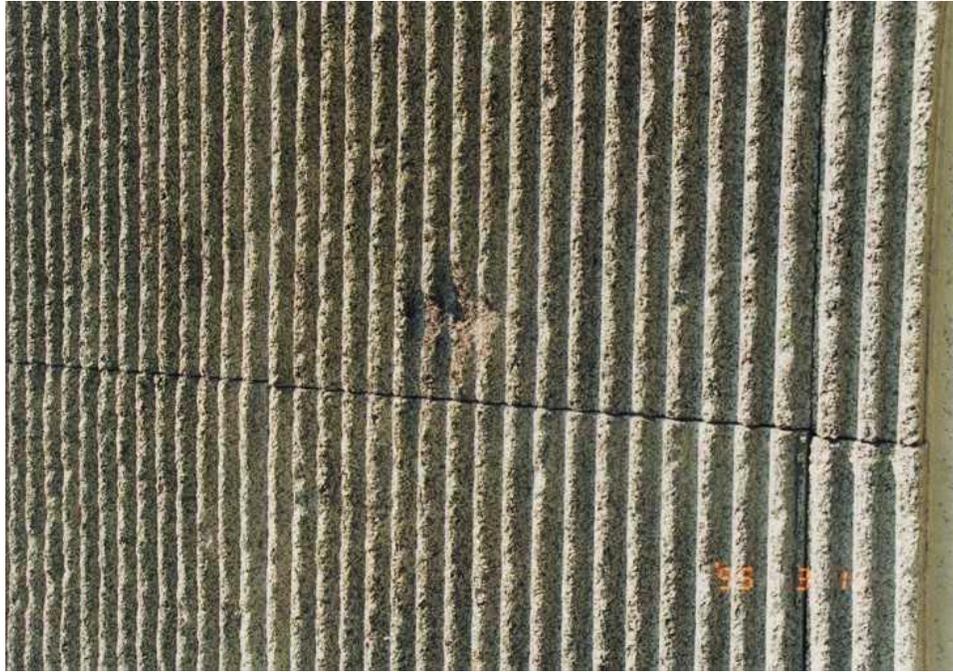
The Durisol panels at all three research sites are also susceptible to wind-blown and tire thrown objects. The panel in Figure 8 is from the Delaware County research site and shows damages caused by a wind-blown or tire thrown object.

Figure 8- Damage caused by a wind-blown or tire thrown object

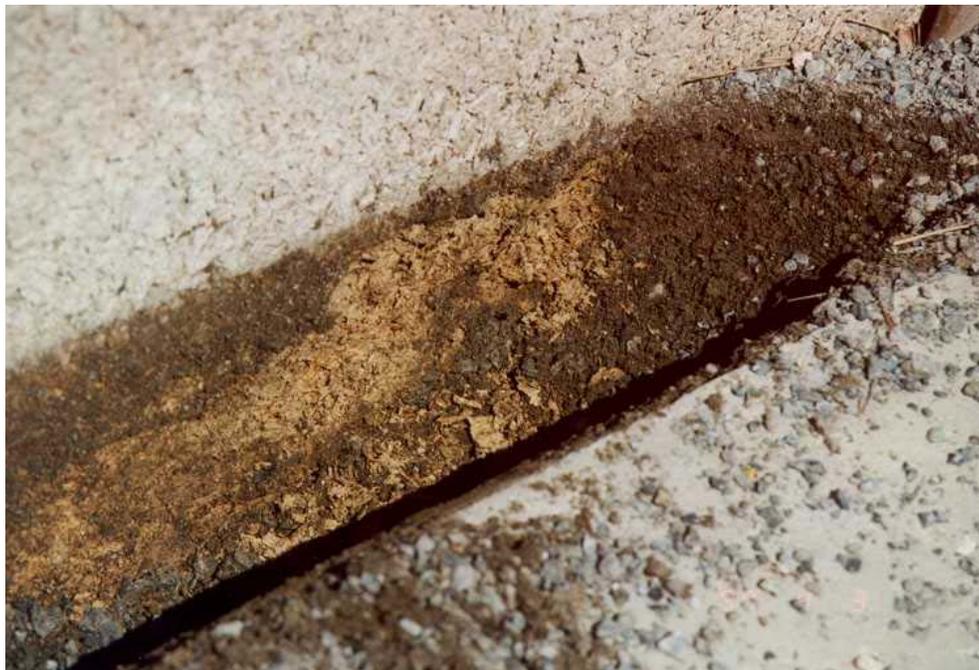
Sections of panel exposed to moisture caused from the build-up of anti-skid material and traffic spray are deteriorating. The deterioration of panels has been observed at all three research sites. Examples of the rotting Durisol panels can be seen in Figures 9 and 10.

Figure 9- Deterioration of a Lehigh County Durisol panel caused by exposure to moisture

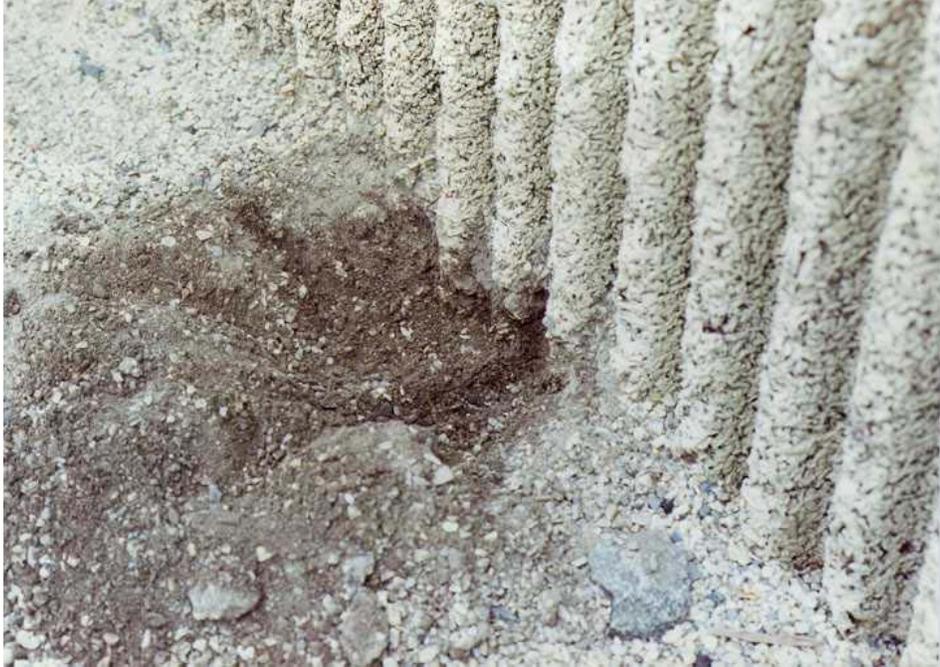
Figure 10-Deterioration of a Delaware County Durisol panel caused by exposure to moisture

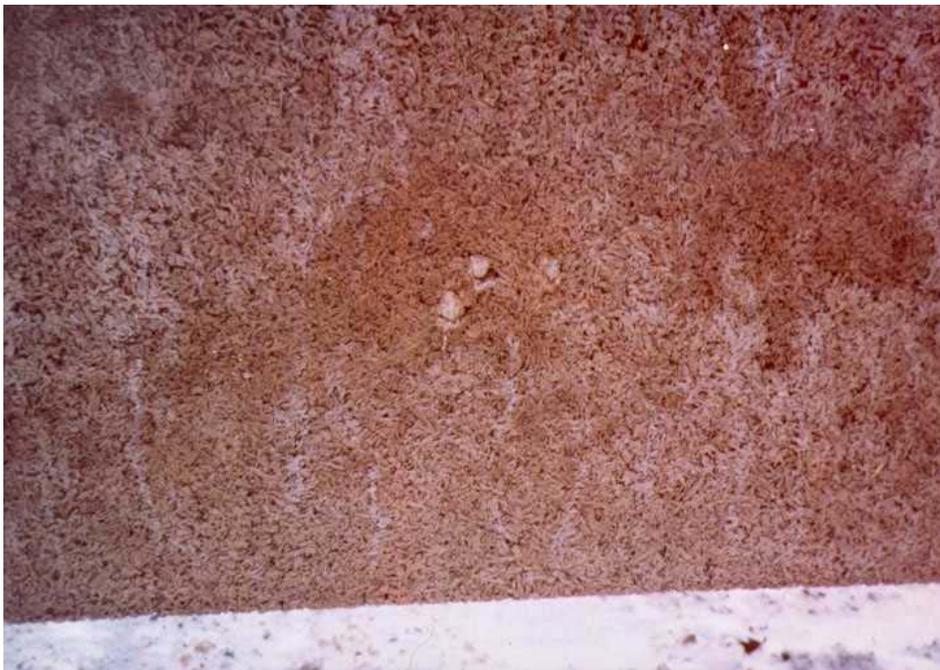
Efflorescence of free lime leaching through the panels from the concrete backing is evident in the Durisol panels at the Lehigh and Delaware County research sites. The efflorescence of free lime decreases the aesthetics of the Durisol Sound Barrier. View Figure 11 for an example of this condition.

Figure 11-Efflorescence of free lime migrating through the Durisol panel from the concrete backing

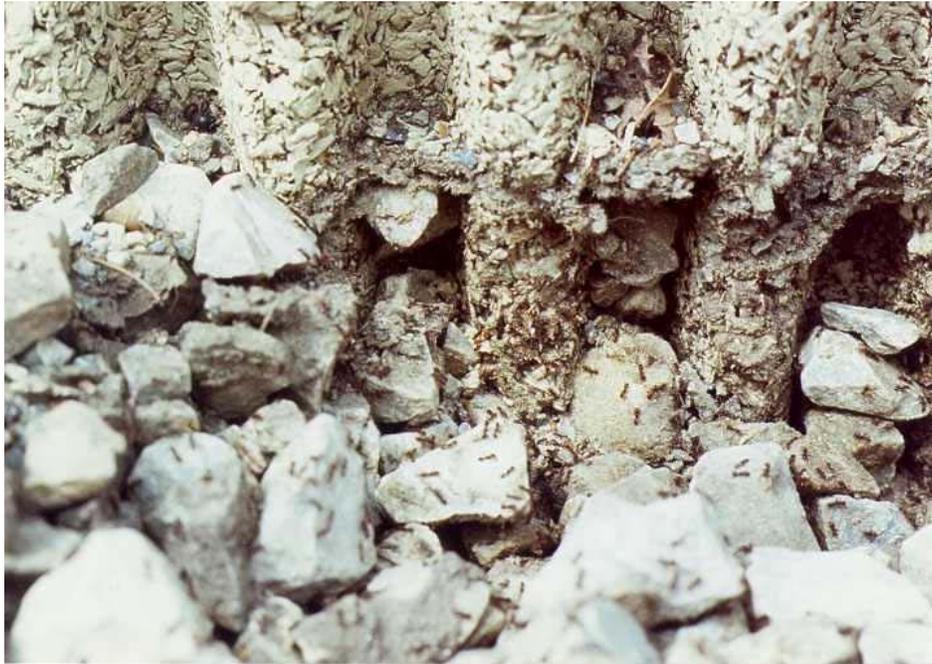
Durisol panels are also vulnerable to insect infestation. Portions of the Durisol noise barrier in Delaware County are found to be infested with carpenter ants. Figure 12 shows a photograph of carpenter ant infestation of a Durisol panel.

Figure 12-Carpenter ant infestation of a Durisol panel

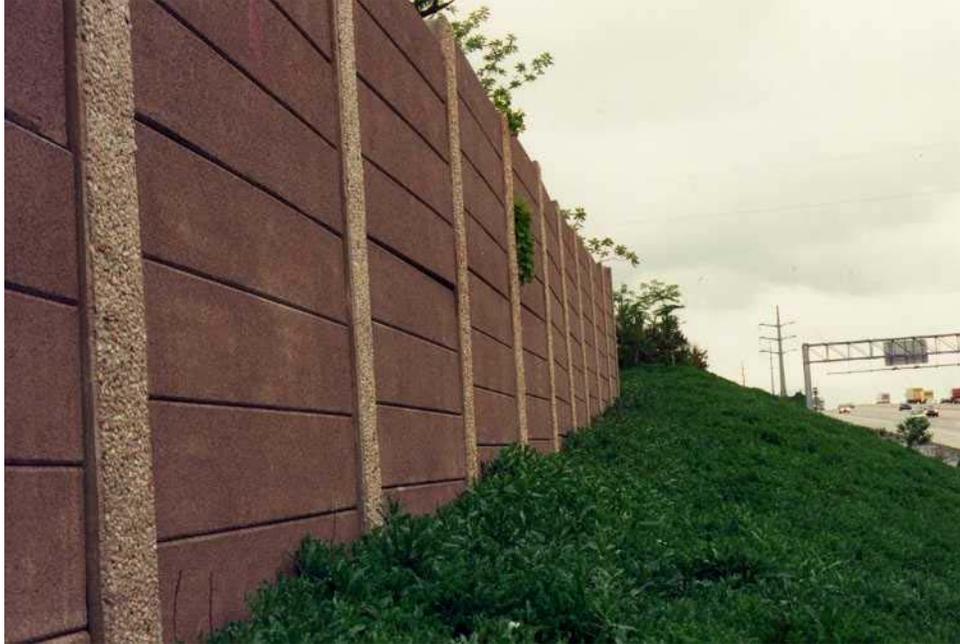
Photo 1-The fourth panel down in the middle section has debonded from the concrete backing.

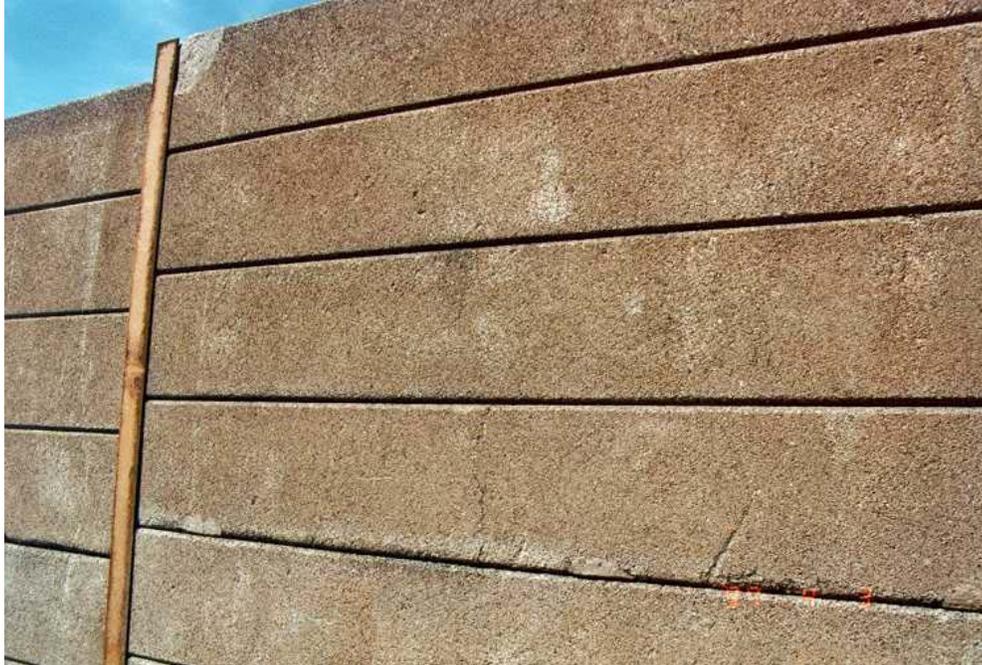
Photo 2-Cracked and damaged panels showing efflorescence.

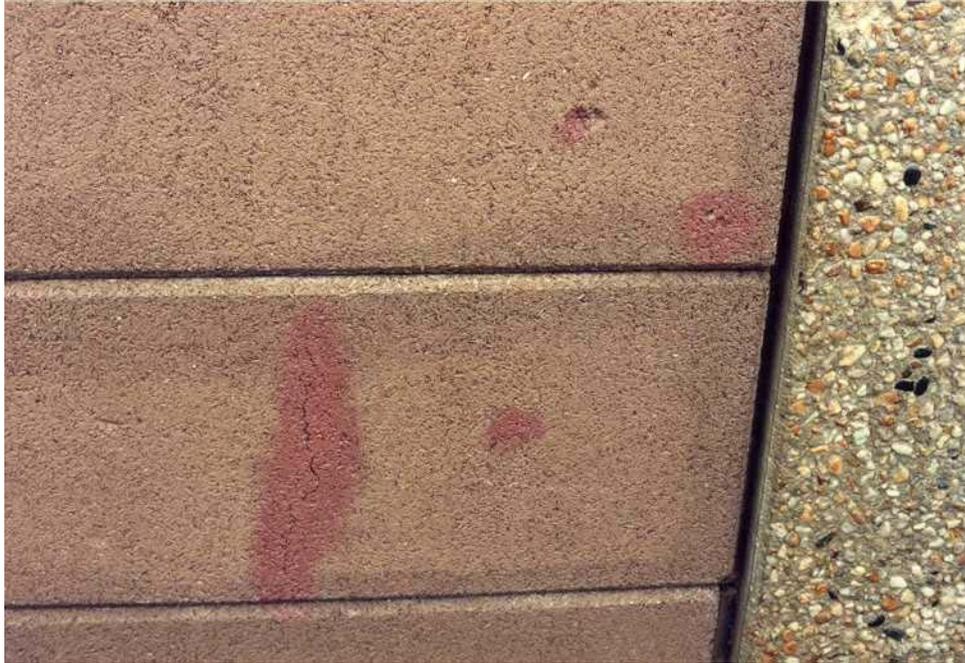
Photo 3-Repair of a debonded and cracked panel.

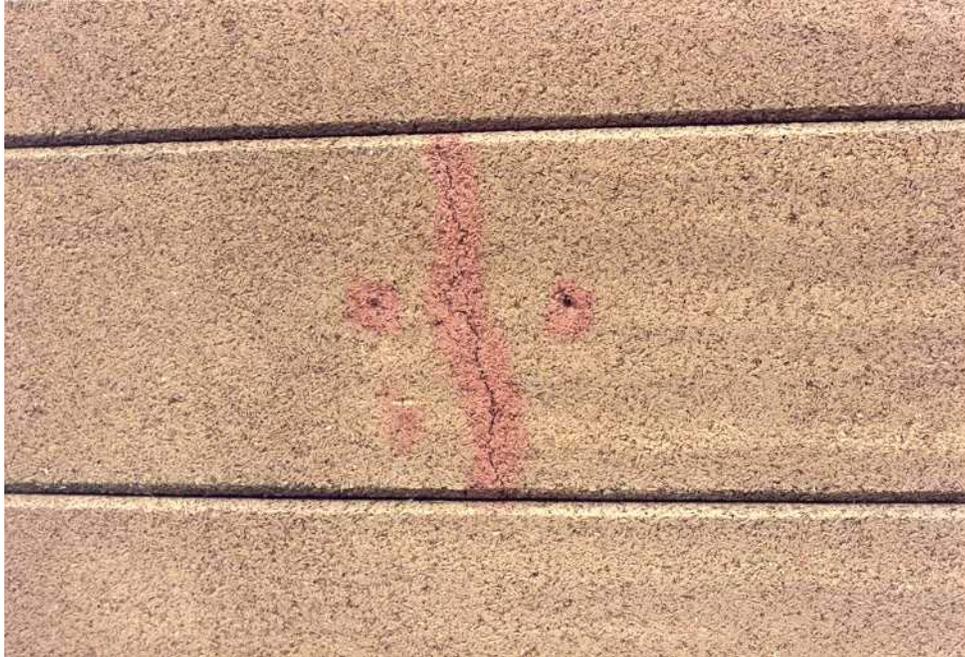
Photo 4-Repair of a debonded and cracked panel.

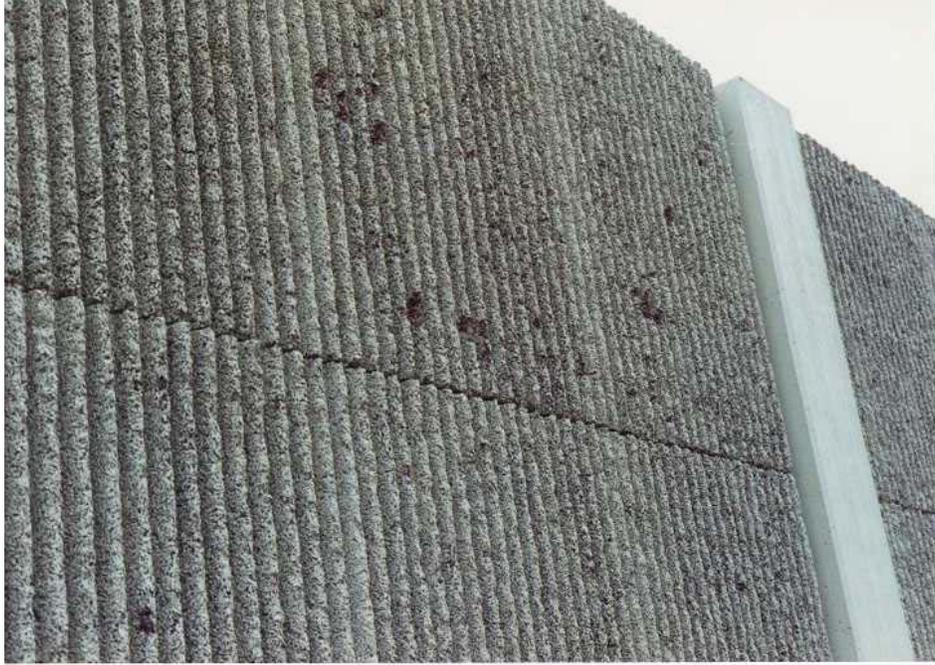
Photo 5-Friable panels falling apart.

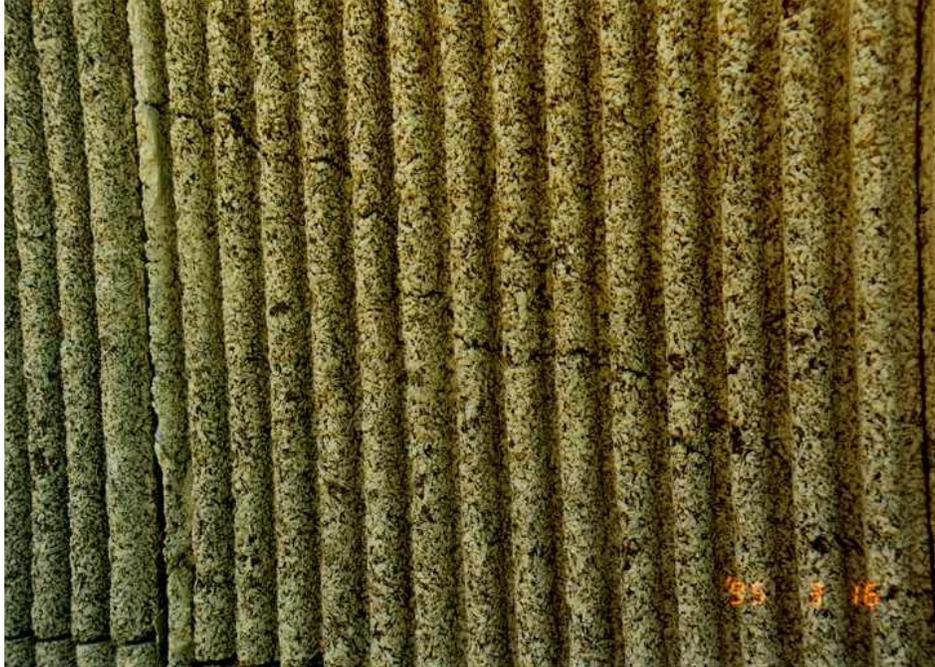
Photo 6-Friable panels falling apart.

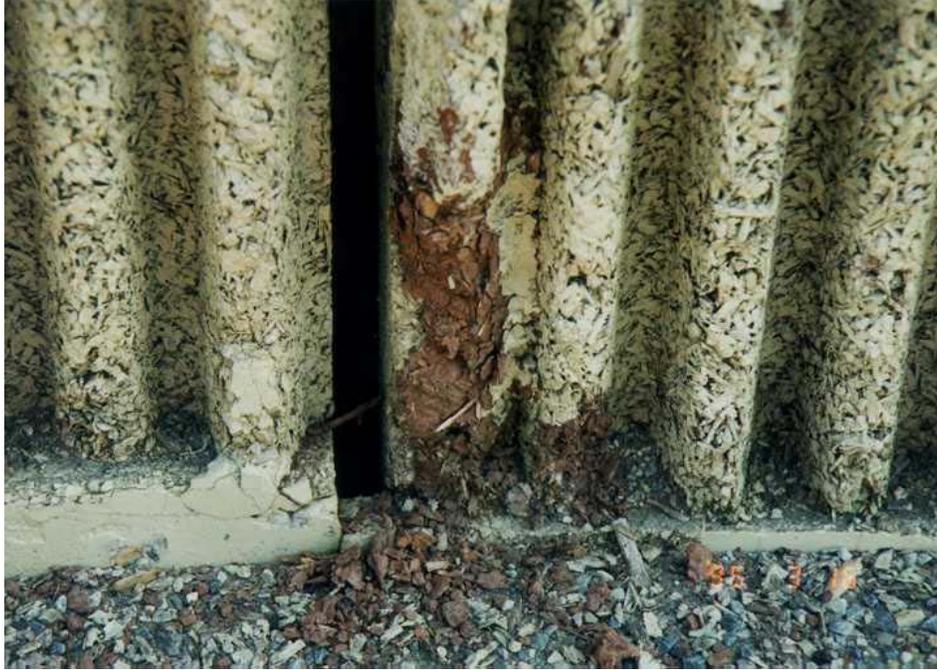
Photo 7-Friable panel falling apart.

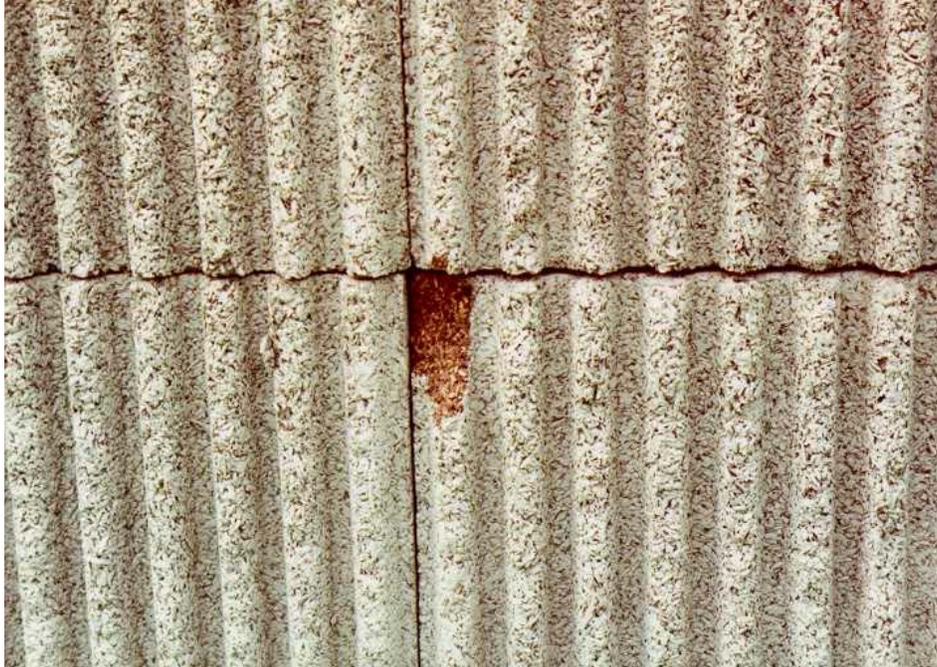
Photo 8-A panel damaged by a wind-blown or tire thrown object.

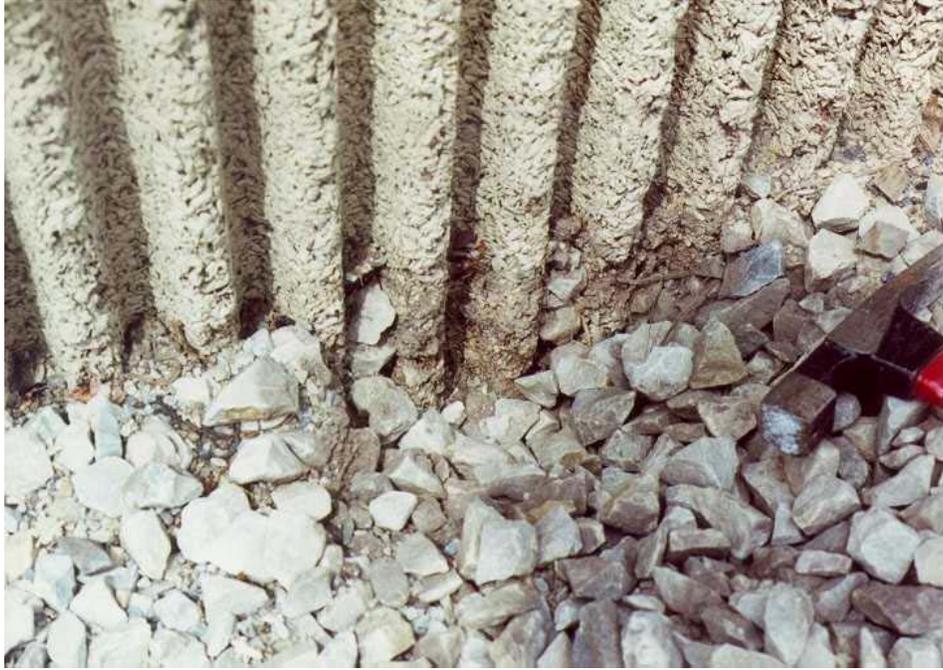
Photo 9-A deteriorating panel exposed to moisture.

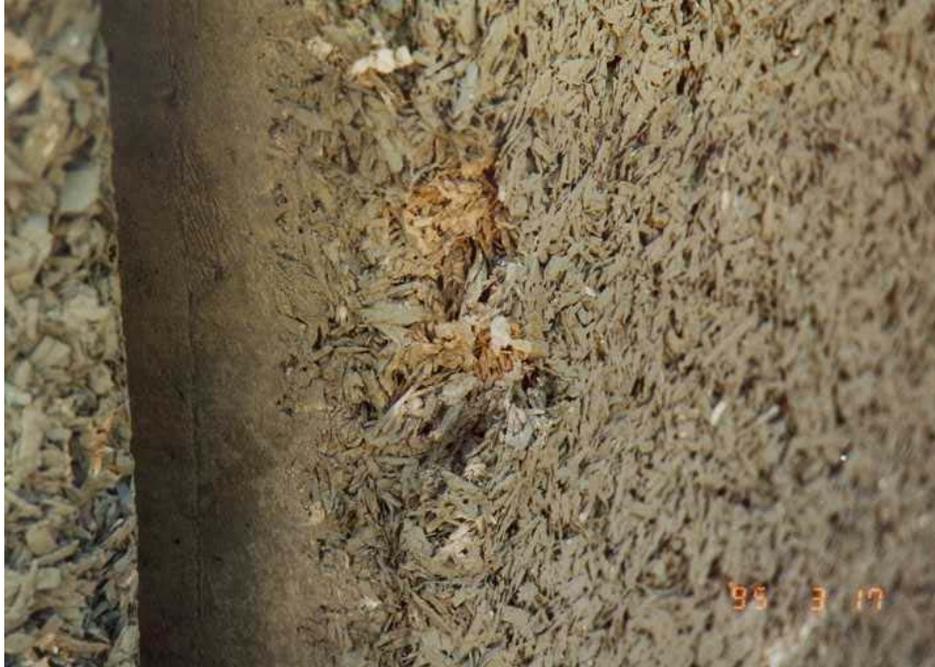
Photo 10-A friable panel falling apart.

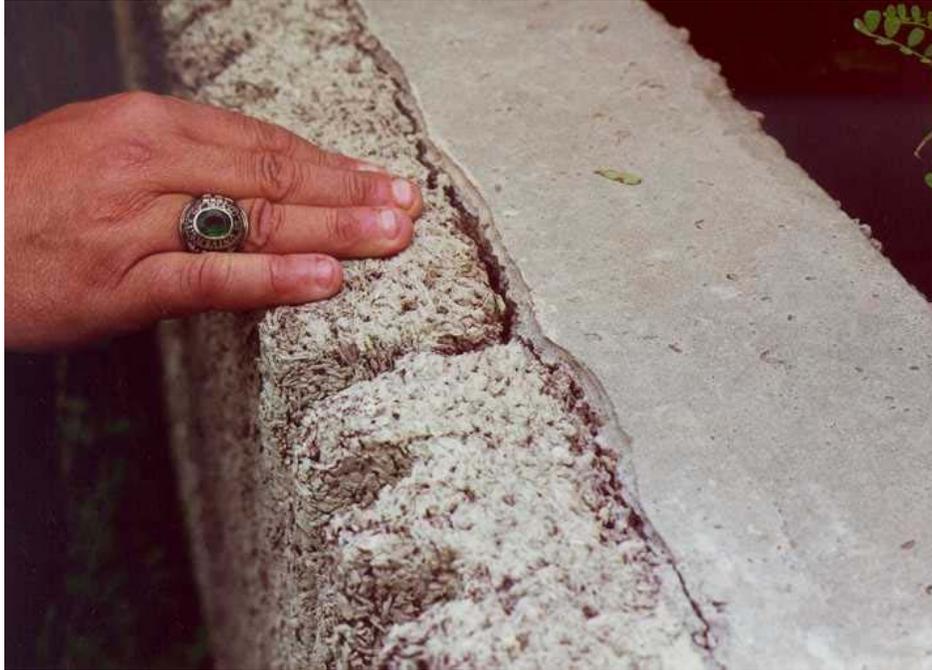
Photo 11-Durisol panel debonded from the concrete backing in Delaware County

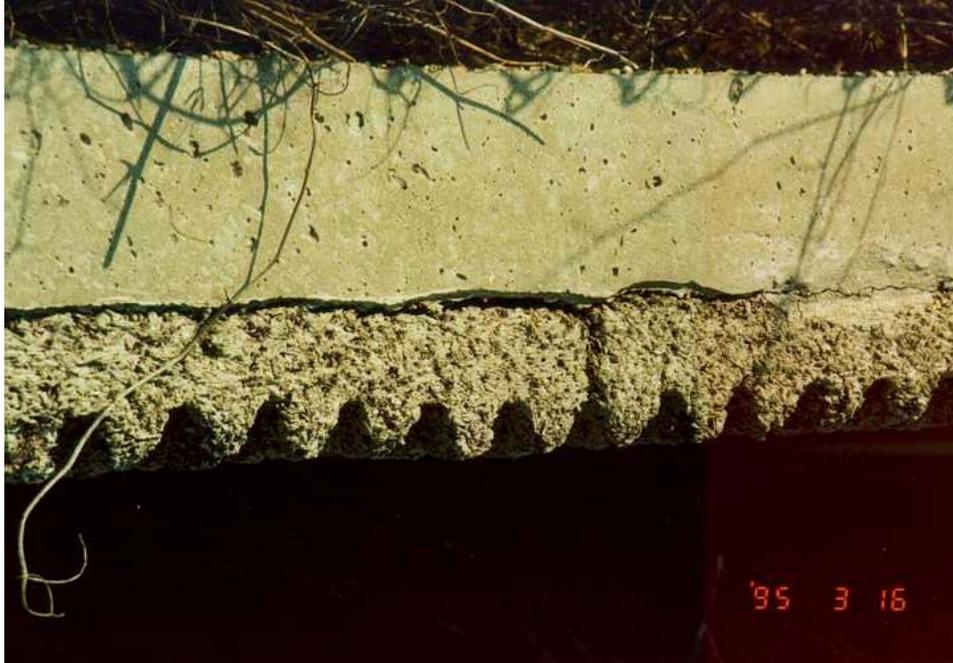
Photo 12-Durisol panel debonded from the concrete backing in Delaware County
